Failure analysis of a jaw in a universal testing machine used for material strength testing

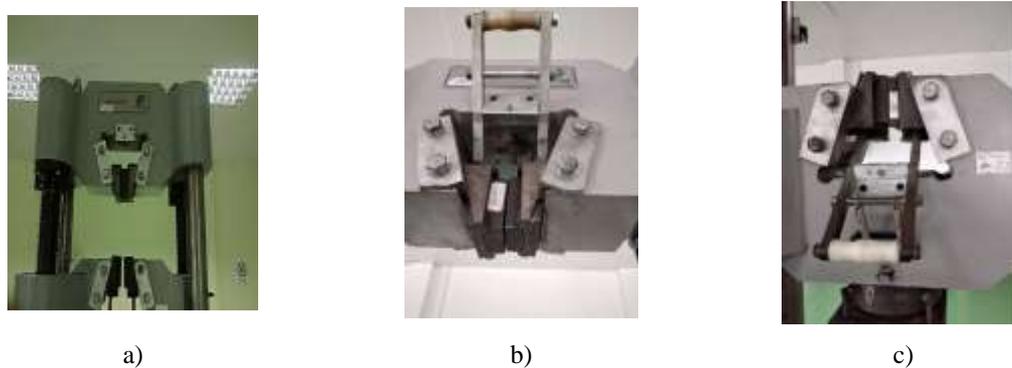
Figure 2. a) Universal Testing Machine, b) Upper jaw, and c) Lower jaw

During the tensile test on a standardized steel sample, one of the parts of the jaws system presented a fracture in its upper part. This part allows the operator to open or close the jaws to introduce or extract the sample. It is not known what caused the failure of the part. As a result, measurements and pictures of the part were taken. Then, a comparative analysis was made, based on the types of failures found in the literature review [12].

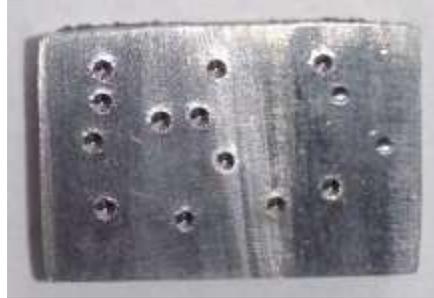
Figure 3. Sample with hardness test points.

Table 1 shows the hardness test results of the sample. The material has a uniform hardness with an average value of 20.86 Rockwell C. Table 2 shows the spectroscopy test results for each of the elements that make up the sample with their respective percentages.

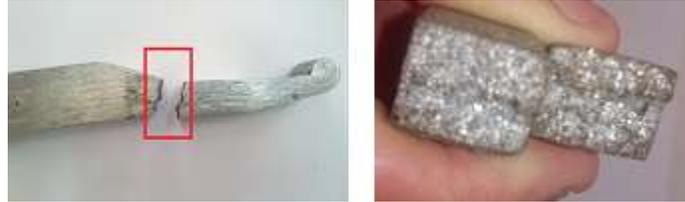
The visual inspection seeks to detail the physical nature of the object inspected. Among these are the size, shape, surface texture, and condition in which it is found, as well as the detail of the defects that allow an assessment of the state in which the material under study is found [18]. Figure 6 shows a fracture of the piece without plastic deformation with a granular appearance on the surface generated by normal stress applied at approximately 90° in the direction of the load. This leads to contemplating the hypothesis of brittle fracture [19].

Figure 6. Fracture in the clamping piece of the jaw.

Visual inspection of the cleavage plane shows that, along the grains, there is high reflectivity with a bright appearance, clearly observable to the naked eye. This is characteristic of a cleavage failure (see Figure 6). The small irregularities and voids observed in the micrographs show the cleavage fracture without plastic deformation. Through the inspection, it was possible to observe that the piece was subjected to metal-to-metal contact between the jaws and the samples used in the tests. The effect of friction and the presence of air subjected the piece to a constant process of oxidation, causing the detachment of material.

Following the methodology described in Figure 1, all relevant aspects found were considered as factors that influenced the failure. To prevent future failures, it is necessary to manufacture the part with the appropriate material. The material should be purchased from a certified supplier who guarantees the effectiveness of the heat treatment. To avoid oxidation caused by the contact between the jaw and the sample during the tests, it is proposed to use AISI 304 cold-drawn stainless steel for manufacturing the clamping part of the universal testing machine. The material proposed has the specific properties presented in Tables 5 and 6 [23].

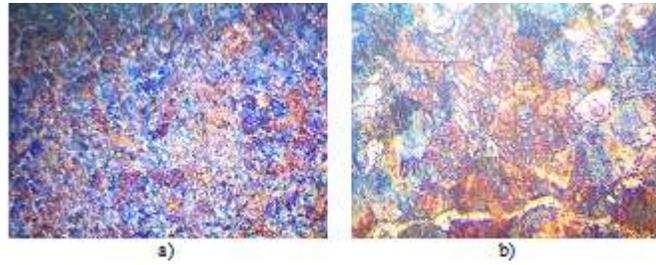
Figure 7 shows the optical micrograph of the sample etched with Nital at different magnifications. Figure 8 shows the sample etched with picral. The metallography reveals the formation of martensite obtained by the rapid cooling of austenite. This is a mixture of lath and plate morphologies with a typical formation of medium-carbon steels [20]. Martensite is a single-phase metastable state. In steel, martensite is a tetragonal crystal structure that occurs when steel is rapidly cooled from the austenite phase [21].

Figure 7. Metallography of the sample etched with Nital at different magnifications: a) 100X, b) 400X

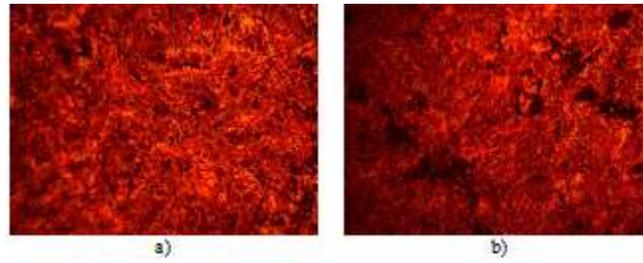
Figure 8. Metallography of the sample etched with Picral at different magnifications: a) 50X, b) 400X.

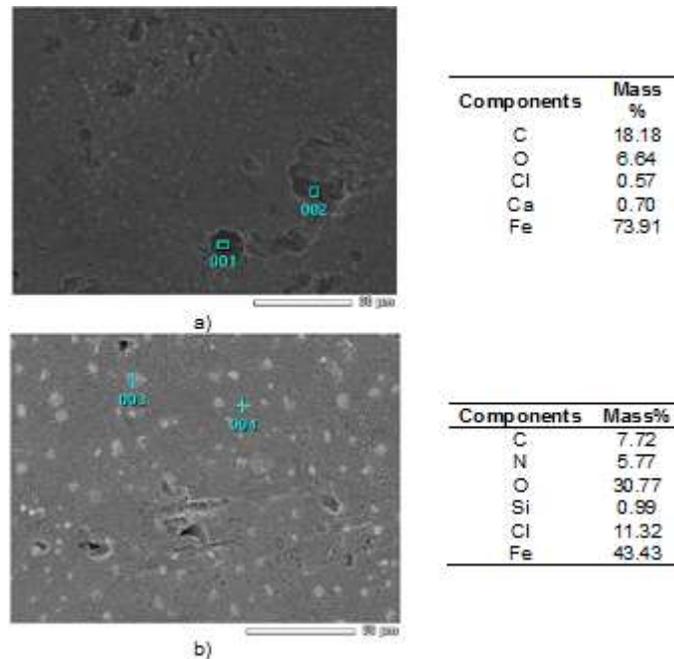
Figure 9 shows the SEM micrograph using EDS. Chemical elements are present in the section analyzed. Also, non-metallic inclusions are present, particularly hard and non-deformable inclusions.

Figure 9. Scanning Electron Microscopy (SEM/EDS): a) Sample etched with Nital, b) Sample etched with Picral.

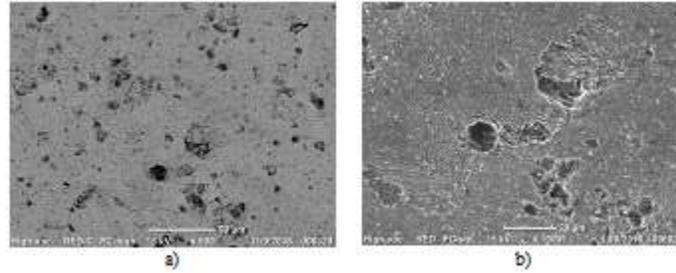
Figure 10 corresponds to the SEM images of the sample that was chemically etched with Nital. Figure 11 shows the sample that was chemically etched with Picral. The micrographs show a matrix with certain porosity that shows irregularities and voids, as well as separation and precipitation of carbides at the grain boundary.

Figure 10. Scanning Electron Microscopy (SEM), Sample etched with Nital: a) zoom 500X, b) Zoom 1000X.

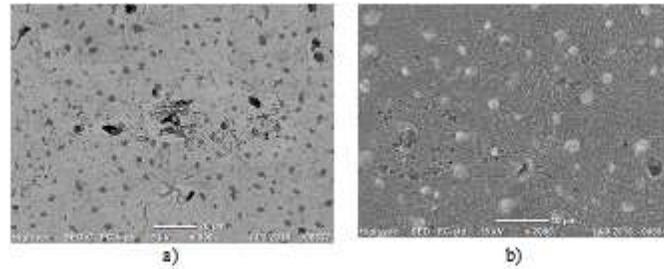
Figure 11. Scanning Electron Microscopy (SEM), Sample etched with Picral: a) 800X b) 2000X.

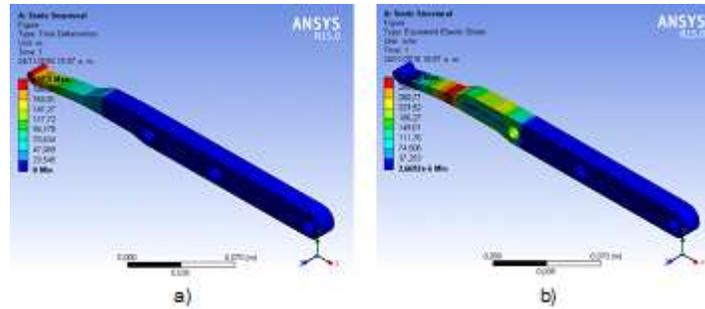
Figure 12 shows the simulation for the applied load using AISI 1040 water quenched steel. The modeling shows the maximum deformation and stress supported by the part. When observing the location where the highest stress concentration occurs in the simulation, detailed in red, it is verified that it is the same area where the failure occurred, as shown in Figures 5 and 6.

Figure 12. Finite Element Method for the material proposed, AISI 1040 Stainless Steel. a) Maximum deformation, b) Maximum stress.

During the quenching, the material did not create a homogeneous martensitic surface layer, nor did it create well-defined iron carbides. The carbides precipitated at the grain boundary, and non-metallic inclusions were generated, probably by slower cooling. The finite element analysis showed that the material suffered a plastic deformation of 0.3 %, evidencing fatigue. The precipitation of carbides at the grain boundary and the inclusion of non-deformable, non-metallic elements, as well as the high content of metals such as manganese with body-centered crystal structure, accelerated the fatigue failure. The failure occurred with little plastic deformation, long before the plastic limit of the material was reached, causing the fracture before the matrix completed its plastic deformation.

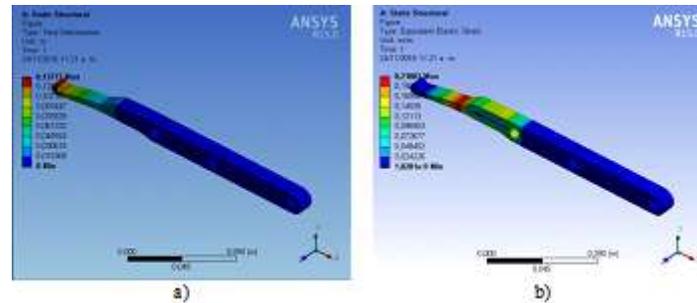
Figure 13. Finite Element Method for the material proposed, AISI 304 Stainless Steel. a) Maximum deformation, b) Maximum stress.

The material proposed was simulated by the finite element method in ANSYS, as shown in Figure 13. The piece supports the loads with deformations that remain in the elastic limit, with a maximum plastic deformation of 0.00021%.
