Sustainable Habitat Plan for Conservation of Hilly areas: A Case Study of Kannur District, Kerala State

This paper highlights the information about the recent landslides occurred in hilly areas of Kannur district and finally the study concludes that geotechnical study, field inspection, investigation and testing and slope stability analysis has a key role in the Sustainable Habitat Plan for conservation of hilly areas of Kannur District in Kerala State.

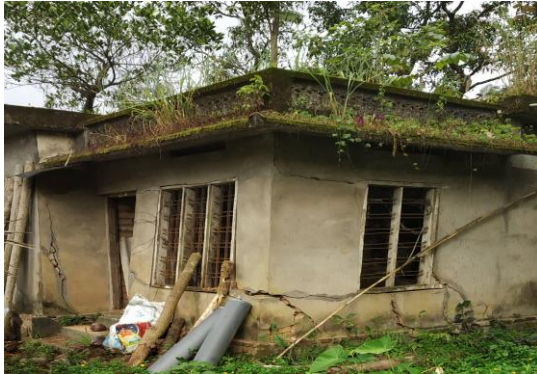
Fig 1.2 Houses which developed structural cracks at Santhigiri

During the heavy rain in the month of August 2018, hill slopes in Santhigiri area of Kelakam Grama Panchayat had slipped. Cracks were developed in around 26 houses and acres of agricultural fields in this area. One of the major slips had occurred at Kailasanpadi ($75.859628^{\circ}\text{E}, 11.912070^{\circ}\text{N}$) the 7th ward of the Panchayat in the evening of August 11 and at the morning hours of the ensuing day. Three of the houses had become totally uninhabitable by the incident and 69 members of 20 families of the area were evacuated to the nearby Govt. Lower Primary School, Kolihattat Santhigiri (Fig. 1.2 & 1.3).

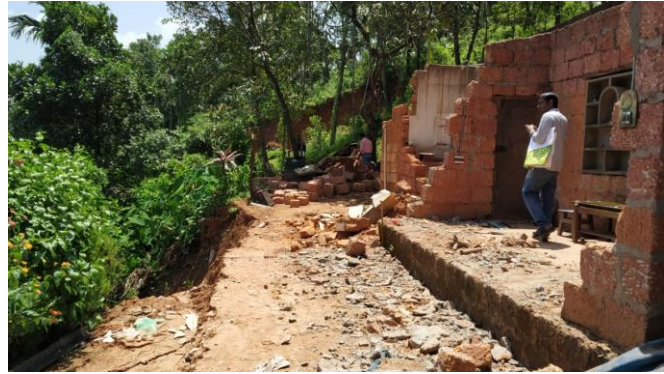
Fig 1.3 Land slip occurred can be seen on slope behind the damaged house

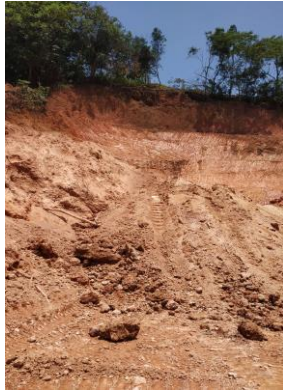
The second selected landside is located in Koolichambra ($75.40^{\circ}30.19''\text{E } 11.58^{\circ}36.19''\text{N}$). This spot falls in the R.S. No.156 (p) of 13th ward of Iritty Municipality in Keezhur Desom and in Keezhur Village. The hill slope was excavated for construction house. The cut height of the steeply cut slope was about 6m. The house constructed by excavation of hill slope at his location and built without any retaining wall or other protection measure, has got damaged due to the landslide (Fig. 1.4.). Seepage water emanating from the toe of the slope was observed at this location (Fig. 1.5.). The cut slope majorly comprised of yellowish to reddish lateritic soil. Soil samples were collected from the cut slope for further laboratory testing.

Fig 1.4.: Landslide at Koolichambra

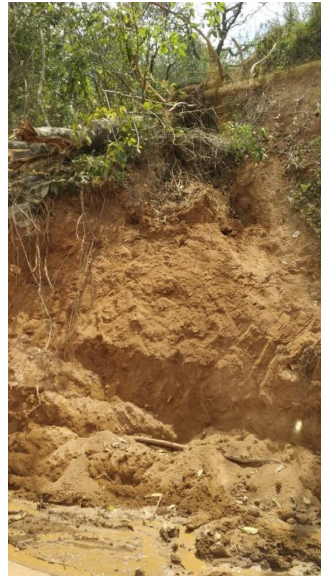
Fig 1.5 Seepage from toe of failed slope

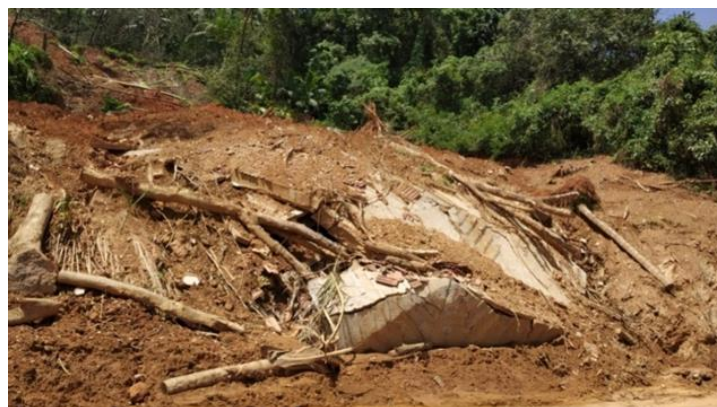
Landslide occurred at the location in R.S. No. 2 of Keezhur Desom ($75^{\circ}38'881''E$, $11^{\circ}58'791''N$) of Keezhur Village (5th ward of Iritty Municipality). In this location the type of landslide occurred appeared to be large and shallow mud flow. Huge quantity of soil mass on the hill slope had slipped and flown down along with the surface and sub-surface water flow. The soil was found to be lateritic soil with major amount of silty to clayey material. The hill slope at this location was found to be relatively steep and was cut at multiple locations for construction of houses and infrastructure. One house and a two storied RCC building which were located on the track of this flow of landslide had collapsed and completely filled with soil and debris. The Edakkanam - Nerambok road had got blocked due the accumulated debris material. Traffic along the road at the spot was restored after clearing the debris.

Fig 1.6 Landslides at Keezhurkunnu
