STONE BASED SMART AGGREGATE FOR STRUCTURAL HEALTH MONITORING OF RC COLUMNS UNDER SEISMIC EXCITATIONS

ABSTRACT

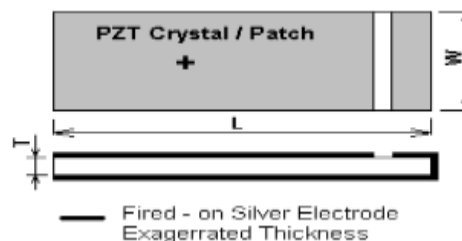
In PZT plates, the major faces are electroded. When these plates are to be glued to a surface / structure, one has to provide electrical connections to the bonded surface also. In order to facilitate electrical connections on one side, the bottom electrode (which is bonded to the structure) is brought to un-bonded surface so that both the lead-wires are connected on one side.

Fig:2 Geometry Of PZT

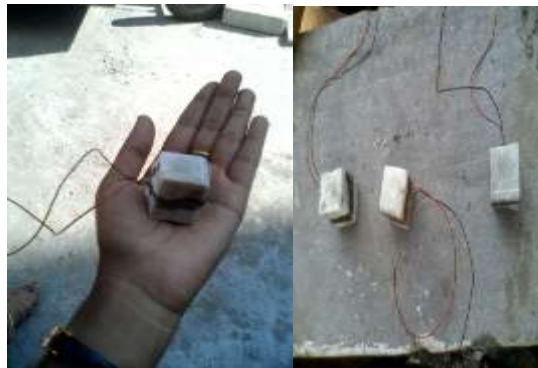
The proposed SA consists of a piece of PZT patch connected with a piece of two-wire cable and a pair of marble blocks. The commercially available soft PZT ceramic referred to as P-5H with a major composition of $\text{Pb}(\text{TiZr})\text{O}_3$ was chosen. The PZT's properties, measured by the supplier, are listed in Table1 . Young's modulus of the marble and the epoxy was 51.5GPa and 2.5GPa, respectively, as supplied by the manufacturer. The size of the PZT patch was 15×15 mm, and the thickness was 0.4 mm. The marble blocks were $25 \times 25 \times 12$ mm in size. When the marble blocks were aligned together along the 12mm long edge, a hole with a diameter of 3mm and depth of 10mm was bored to accommodate the cable and the soldering points on the PZT patch. Then the PZT patch was sandwiched between the marble-block pair with structural Araldite epoxy-resin. The calibration test had been conducted and showed that the SA had constant sensitivity at a relatively high stress level. Sensitivity obtained from the calibration test was 1.23×10^5 pC/MPa.

Fig:3 Fabricated Smart Aggregate

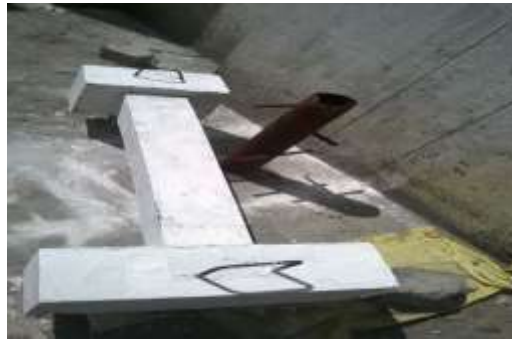
FIG:4 RC Column Specimen

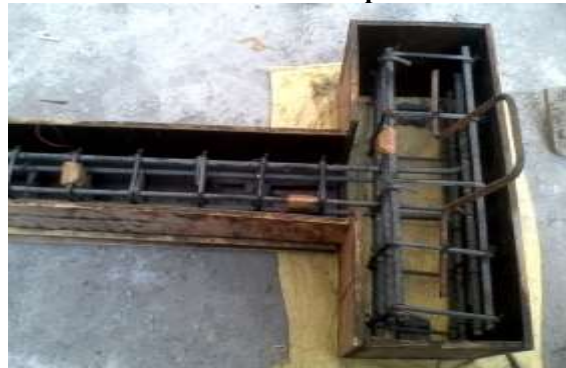
Fig:5 Column Setup Embedded With SA

The wave propagation tests were conducted using the smart aggregates embedded at the three ends (one serving as actuator, and the others as sensor) for damage detection. A stress wave was generated by the embedded smart aggregate at one end and the response signal was captured by the smart aggregate at the other ends). Since the in-plane dimension of the thin square PZT plate actuator in its plane is much larger than its thickness, the major effect of PZT actuation is perpendicular to the beam length direction. Although both the compressive and shear waves are generated, it is anticipated that the captured shear wave is dominating in terms of signal magnitude.

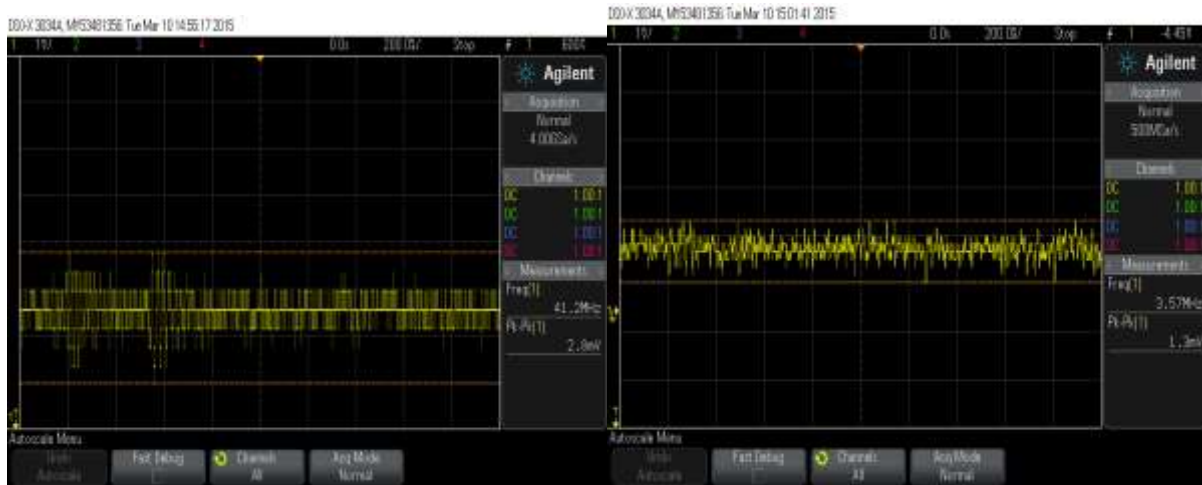
Fig:7 Output From Oscilloscope

The magnitude of the PZT output, as a sensor, decreases with the increasing load value. The maximum sensor output value in test 1 is close to 1 V, while that in later tests it is close to zero. This means that the concrete structure (testing specimen) was a good conduit for wave propagation in test 1, when the structure was healthy, and the wave propagation was almost totally block.

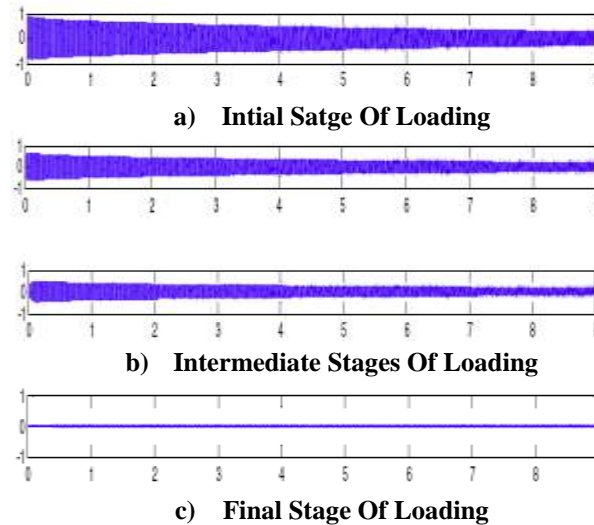
Fig:8 Result Showing Decrease In Voltage After Cyclic Loading Of Specimen At Each Step Taken By Dso.

In later test due to loading, damage occurs, in which the waves with lower frequencies attenuate much less than those with higher frequencies. For the time history response of the PZT sensor during each test, the magnitude decreases with time. Since the excitation signal was a sweep sine wave from a low frequency (750KHz) to a high frequency (2MHz) with respect to time, it can be concluded that the PZT sensor magnitude decreases with the increasing wave frequency, i.e., the waves with lower frequencies attenuate much less than those with higher frequencies.

A dramatic drop in sensor responses means dramatic increases in crack width, which is often caused by structural failure. It is noted that there is a dramatic reduction of the sensor output from test 6 to test 7, which means the damage in the structure, mainly cracks, became so severe.

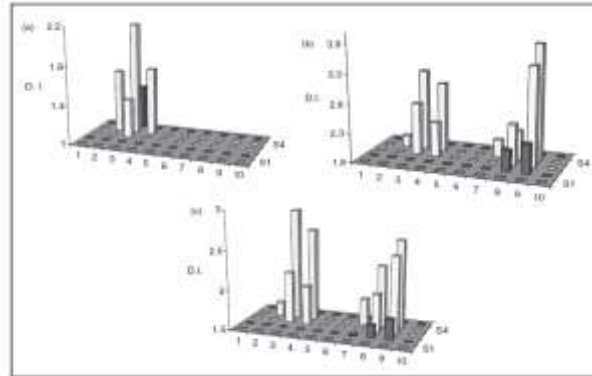
Fig : 9 Graphical Results From RMSD

In this paper, the damage index is formed by calculating the RMSD between the energy vectors of the healthy state and the damaged state. The energy vector for healthy data is denoted as $E_h = [E_{h,1}, E_{h,2}, \dots, E_{h,2n}]$. The energy vector for the damaged state at time index i is represented by $E_i = [E_{i,1}, E_{i,2}, \dots, E_{i,2n}]$. The damage index at time i is defined as

The proposed damage index represents the transmission energy loss portion caused by damage. When the damage index is close to zero, it means it is in a healthy state. When the damage index is bigger than a certain threshold, this means damage appears. In this case, the greater the index, the more serious the damage is.

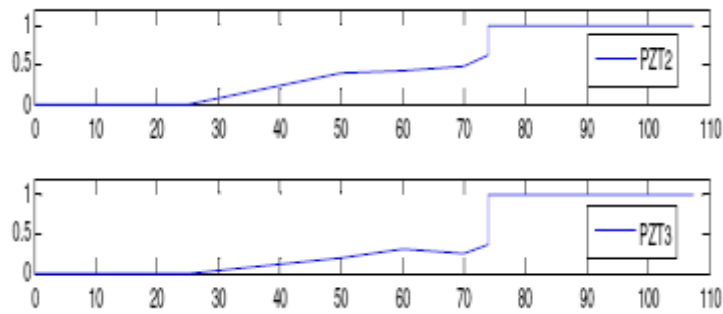
Fig : 10 Crack Width Increased At Different Stages Of Loading (Extracted Result From Matlab)
