Failure analysis of a jaw in a universal testing machine used for material strength testing

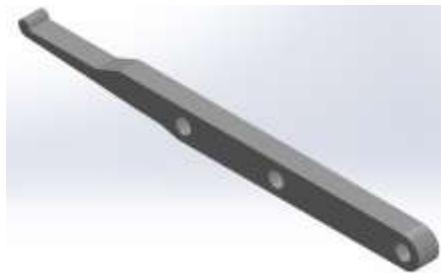
Figure 4. Solid of the piece modeled in solidworks.

The piece under study was modeled using SolidWork CAD software. Then, the behavior of the part was simulated by applying the loads for working conditions using Ansys software. Figure 4 shows the solid of the part modeled in SolidWork.
